Diagnostic analysis of right main canal command of West Banas irrigation project

Abstract

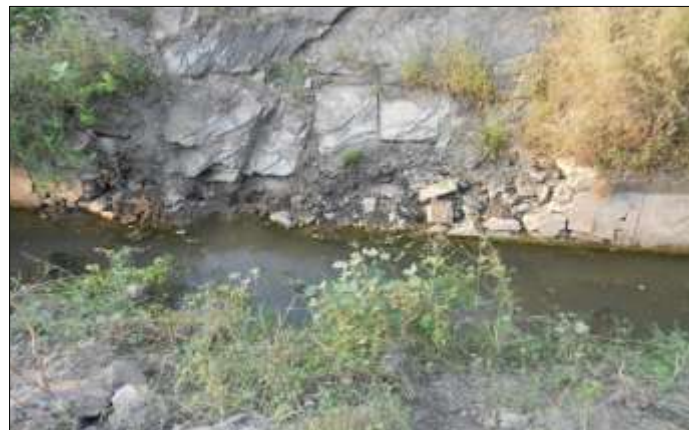
The canal lining was observed to be damaged at 25 locations on the Right Main Canal (Plate-1 & 2) and at a number of locations throughout the canal network. Knowledge of how and how much water should be applied to the field for effective crop yield is lacking among farmers in the command area. They damage the canal lining or minor children because they get excessive water and avoid other labor staff to irrigate the fields which they have to do because the drains are far away from their fields. This causes large losses of water through seepage from the damaged section and subsequently affects the designed discharge in the canal section. Cracks in the canal lining were also observed at a number of locations in the canal network, which requires maintenance to prevent water wastage through seepage from the cracks. Most farmers irrigate their fields until; the water does not stop in the channels.

Fig 4: Damaged lining of RMC

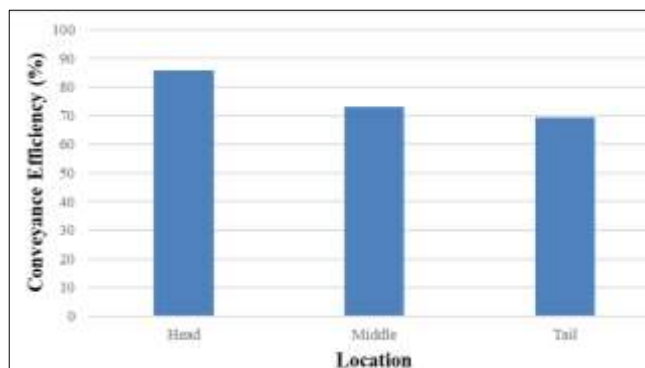
The transport efficiency of the right main channel (RMC) was measured at three locations selected in the head, middle and tail sections, each 200 m long. Inflow and outflow were measured for these sections. Several times throughout the irrigation season. For the right main channel in the head section, the achieved transport efficiency was 85.80 percent.

73.04 percent and 69.24 percent were observed in the middle and tail reaches. An average transport efficiency of 76.02 percent was found for the entire right main channel, which is within an acceptable range for the distribution systems.

Fig 5: conveyance efficiency of RMC

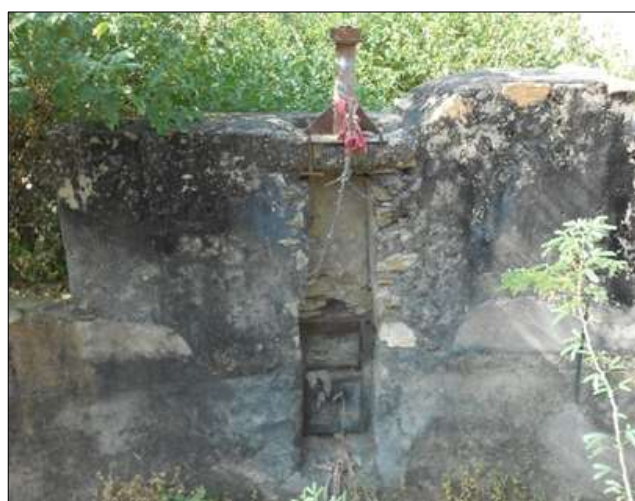
Most of the gates were found tempered or damaged throughout the canal network and at 2 locations on the Baroda branch canal. So no flow control or regulation (opening or closing) can be practiced. Tempered or oversized pipe outlets were also found in the channel network. Observations were also made at other unauthorized outlets and were found to be nine outlets at RMC, many outlets at minors.

Fig 6: Damaged gate of RMC
