Ultrasonographic studies of rumen in plastic impacted cattle

G Kamalakar, BN Nagaraja, L Suresh, A Sahadev, N Prakash and V Mahesh

Abstract

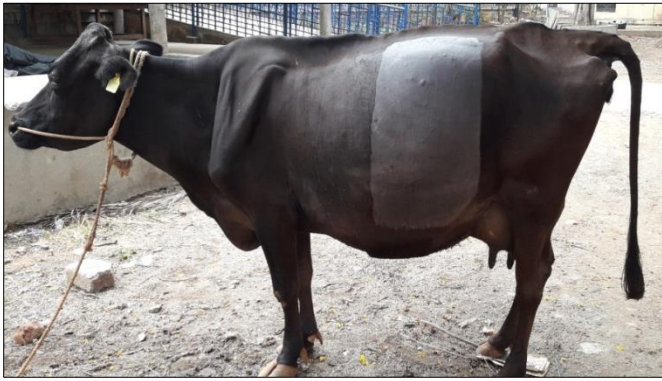
Fig 1: Photograph showing the site prepared for scanning.

The horizontal area from 12th intercostal space to caudal left paralumbar fossa at tuber coxae; vertically from transverse process of left lumbar vertebrae to stifle fold or subcutaneous mammary vein were shaved and made grease free by cleaning with soap water (Fig. 1). The animal was restrained in a travis in standing position.

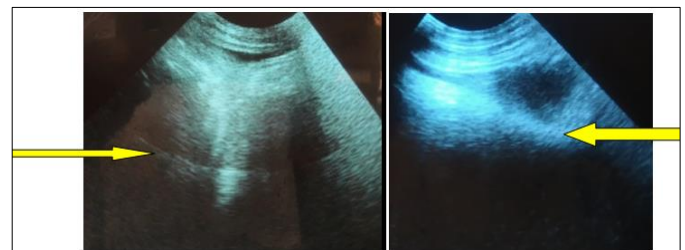
Fig 3: Ultrasonogram showing 'V' shaped notch visible at transverse groove

respectively (Fig. 2). Transverse groove could be identified as V shaped notch (Fig. 3). Stratification of ingesta was not clearly visible in all the plastic impaction cases, but was clear in animals with mild bloat, where, the demarcation from gas to ingesta phase was conspicuous because of reverberation artefact created by gas layer (Fig. 4). However, the transition from fibre mat to fluid layer was not clear in all the cases.

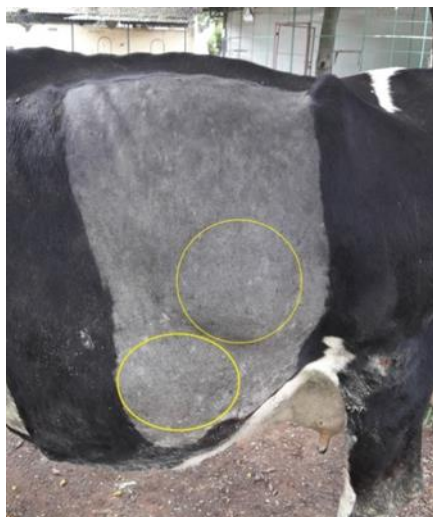
Fig 11: Region of identifying hyperechoic zones indicated by yellow circles
